# **Final Report**

## **TECHNICAL COMMITTEE FOR INSPECTION OF THREE BREACHED TANKS IN BBMP LIMITS AND FOR SUGGESTIONS TO PREVENT FURTHER SUCH INCIDENTS.**

Report of the Technical Committee for inspection of three breached tanks  
in BBMP limits and for suggestions to prevent further such incidents.

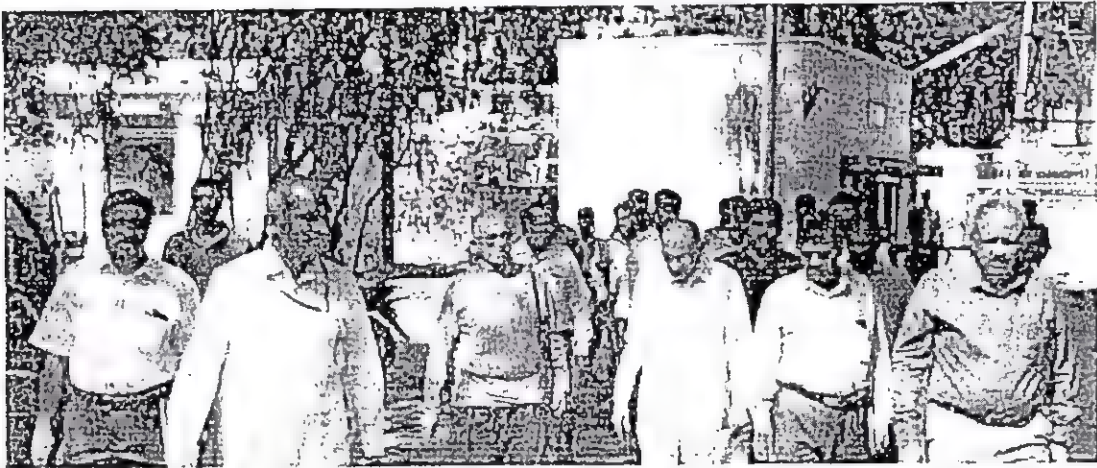
Photo-2(a) – Inspection of Doddabidarakallu tank by Technical Committee with officers

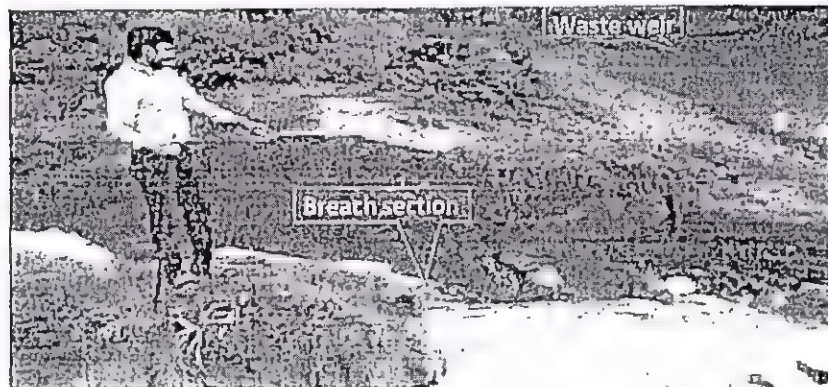
- iii) **The breach in the Doddabidarakallu tank bund is attributable to inadequate compaction of embankment near the sluice after the insertion of pipes and improper closure of pipe insertion in the bund near the sluice aggravated by heavy rains and floating weeds obstructing the water flow over the weir.**

Photo-2(b) – View of Doddabidarakallu weir and the breach section

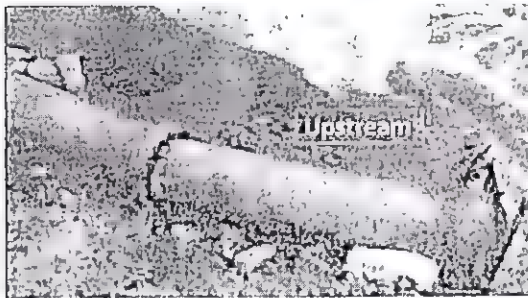
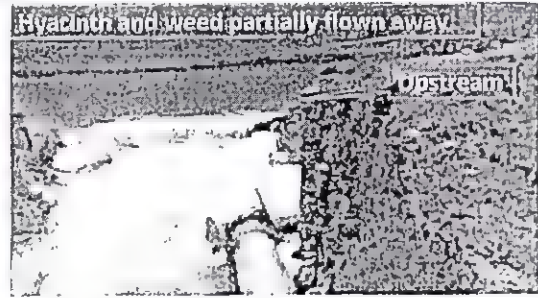
Photo-2(c) & 2(d) – View of pipes inserted in the breach section near sluice

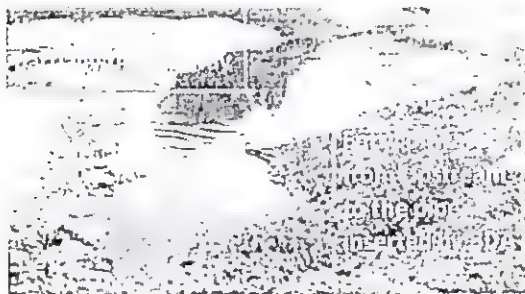
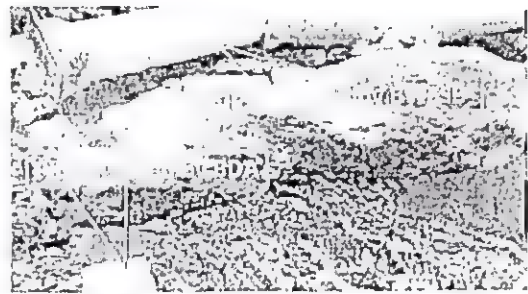
Photo-2(e) & 2(f) – View of pipes inserted in the breach section near sluice

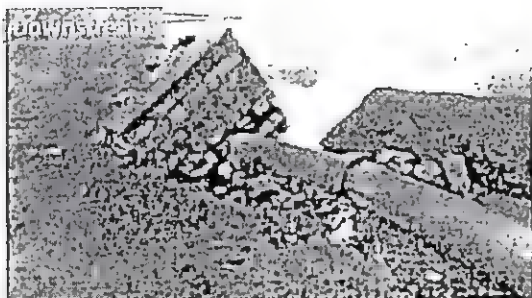
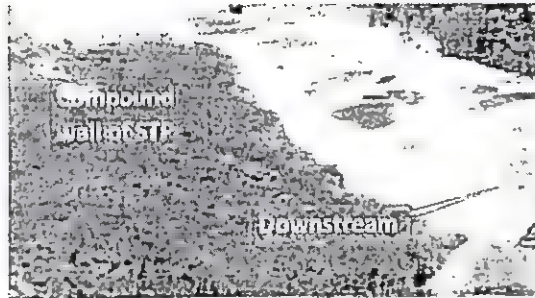
Photo-2(g) & 2(h) – View of pipes inserted in the breach section near sluice and the flooding down of water in the sluice nala next to the compound wall of STP

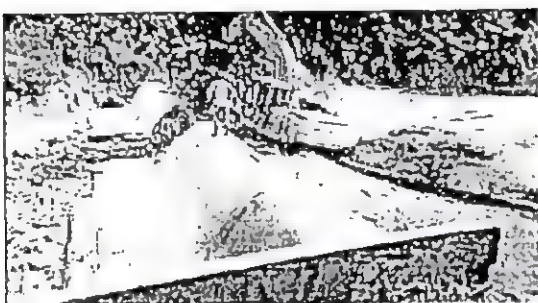
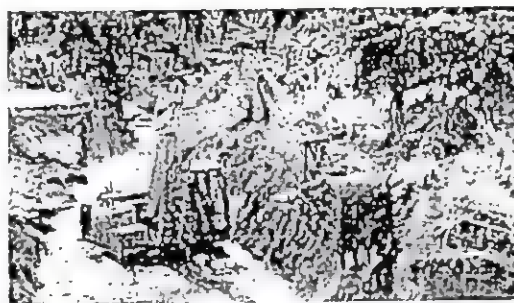
Photo-2(i) & 2(j) – After the breach - Breaking of weir to allow water in raja kalue and widening of raja kalue

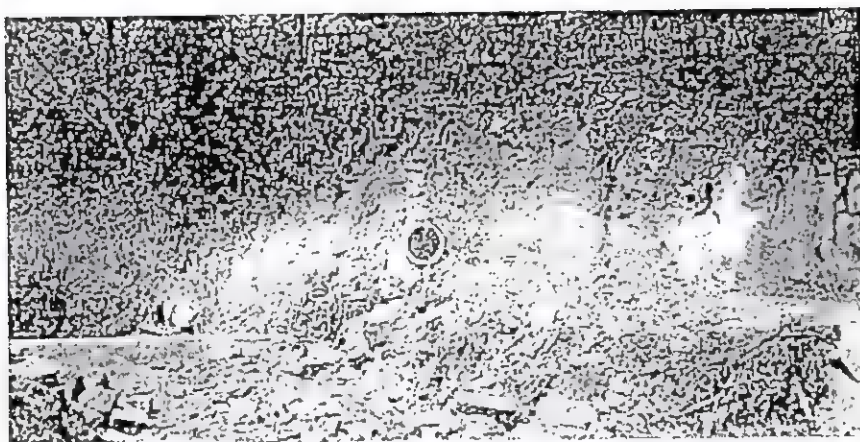
Photo-2(k) Encroachment of weir and illegal insertion of pipes to drain into tank

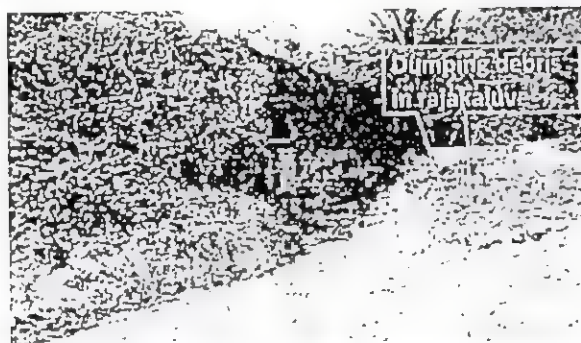
Photo-2(l) Encroachment of rajakaluve by dumping debris

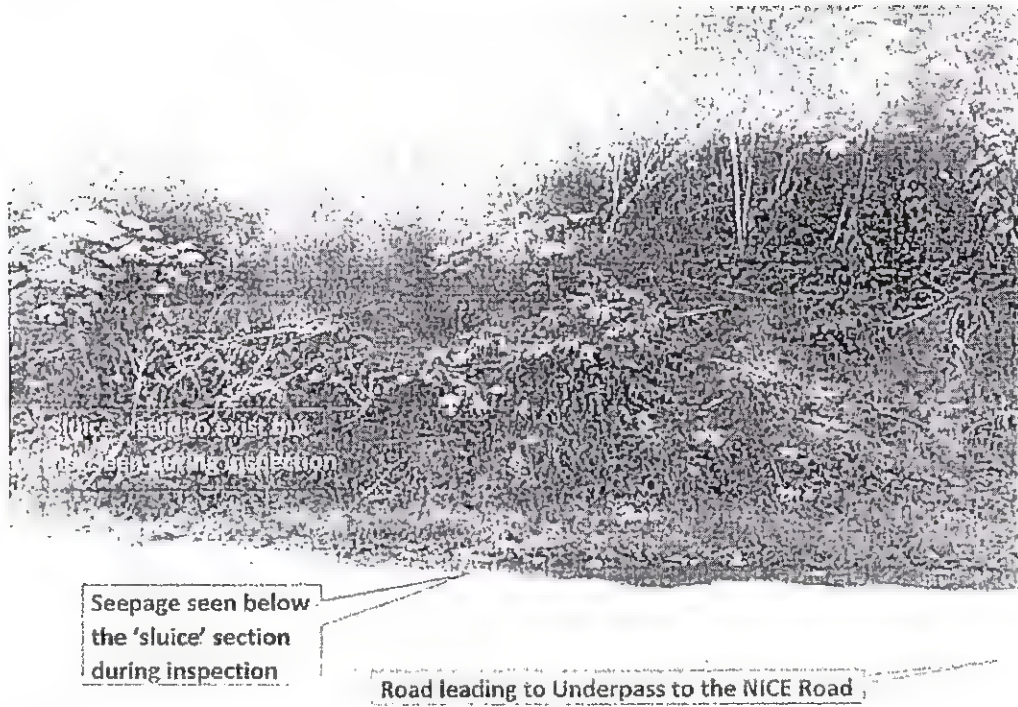
Photo-3(a) – Hosakerehalli tank bund outside view near the sluice

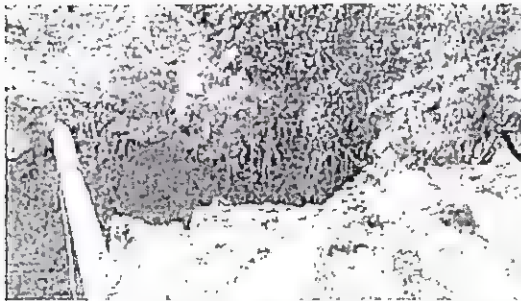
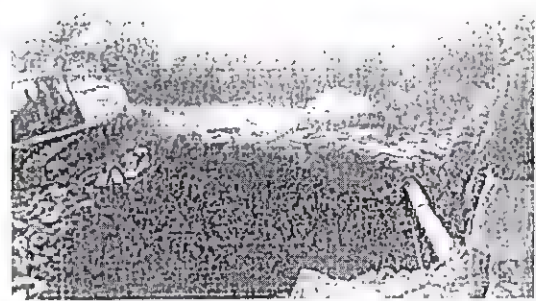
- iv) The breach in the Hosakerehalli tank bund is attributable to inadequate compaction of embankment near the sluice after the insertion of pipes and improper closing of pipe inserted in the bund near the sluice aggravated by heavy rains and the blockage in the raja kaluve downstream of the surplus weir.**

Photo-3(b) & 3(c) – Hosakerehalli tank- View of breach section

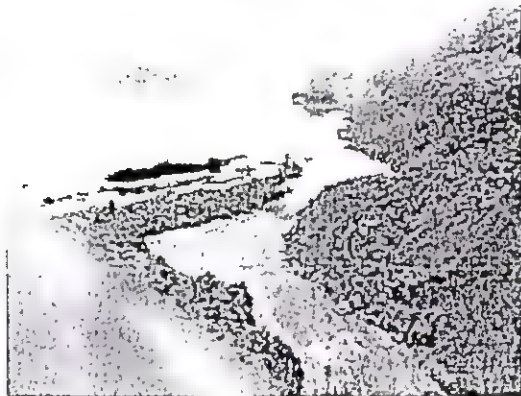
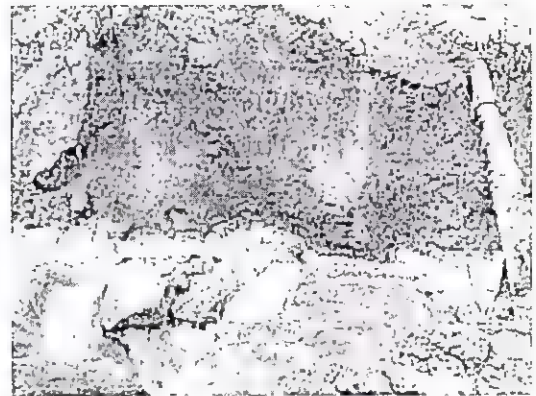
Photo-3(d) & 3(e) – Hosakerehalli tank- Reconstruction of breach section

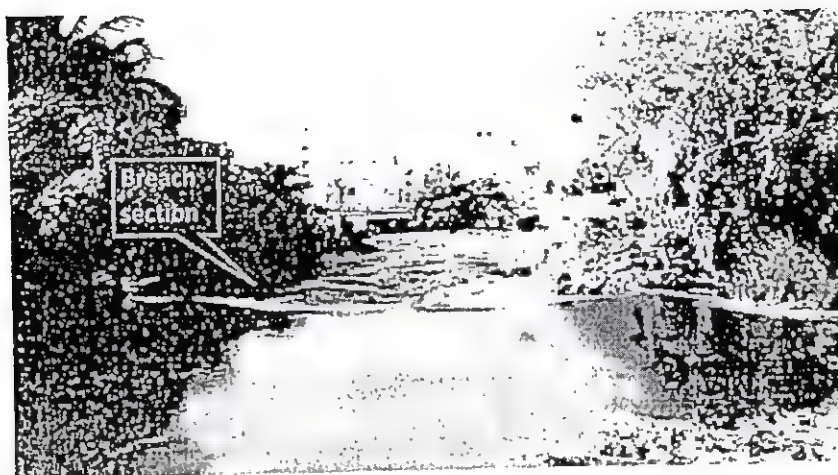
iv) **The breach of the Hulimavu tank bund is attributable to the action of lowering the earthen bund due to ignorance of the consequences of water flow at a place other than the weir. This action has triggered gradual erosion of soil from the embankment and the increasing flow of water has resulted in the breach of bund.**

Photo-4(a) – Hulimavu tank bund breach

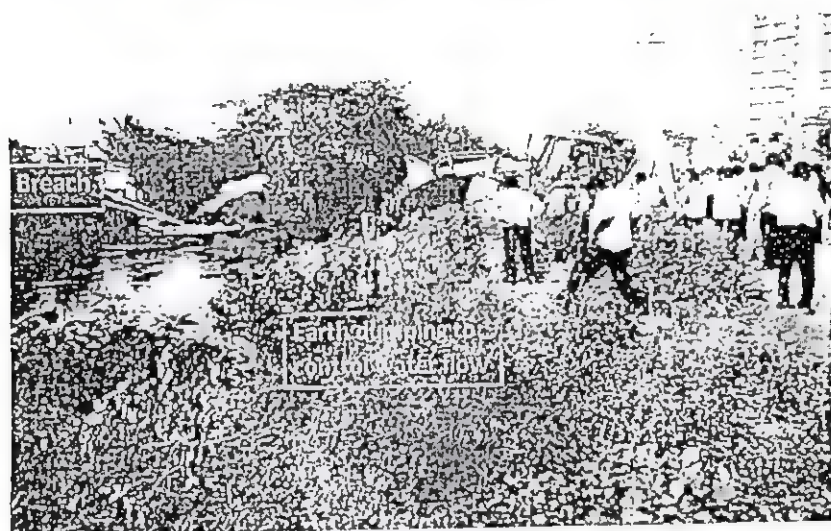
Photo-4(b) – Hulimavu tank bund breach controlling

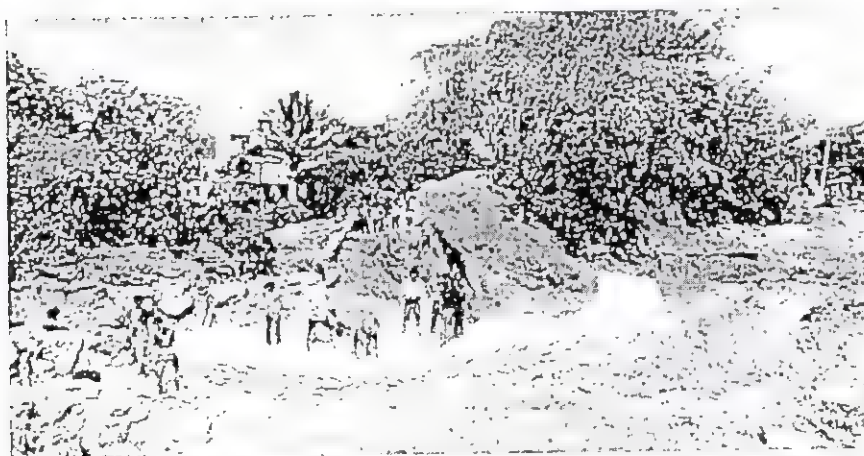
Photo-4(c) – Hulimavu tank bund restoration work after the breach

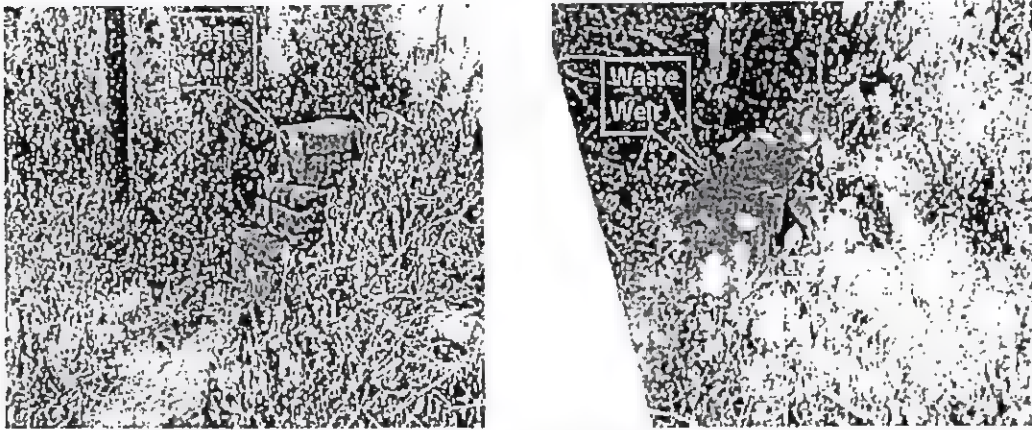
Photo 5 (a) & 5(b)- Waste weir of Singapura tank is neglected as road is formed after the weir in the downstream raja kaluve

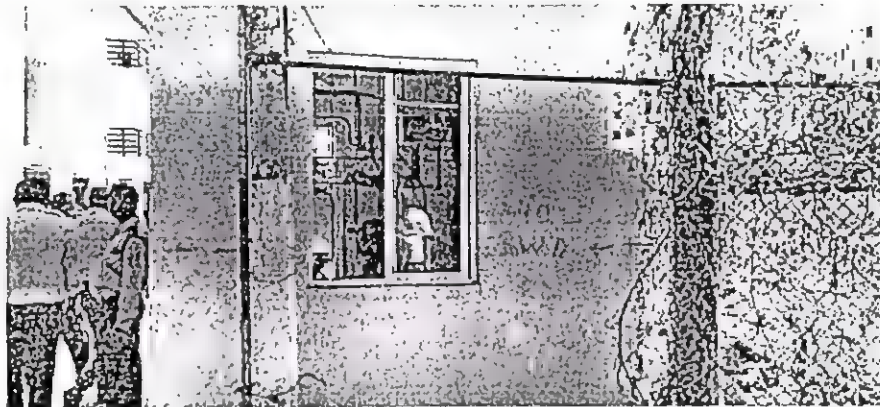
Photo 5 (c) – Encroachment of nala down the sluice of Singapura tank

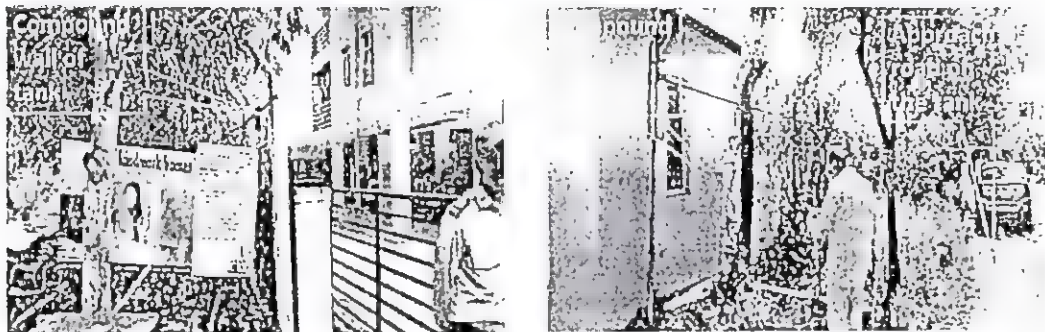
Photo 5 (d) – Encroachment of tank bund for formation of approach road

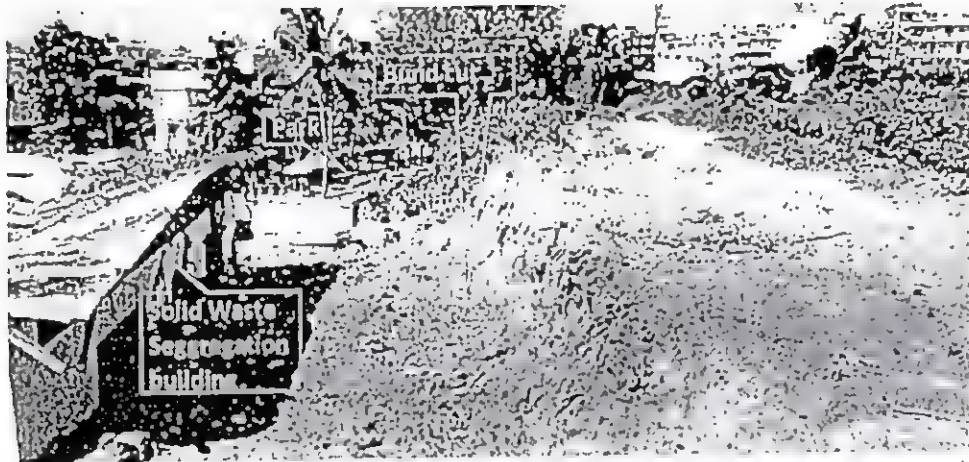
Photo 6(a) – Bund of Gowdanapalya tank cut and width diminished to accommodate a building for Solid waste segregation and further to accommodate Storm Water Drain

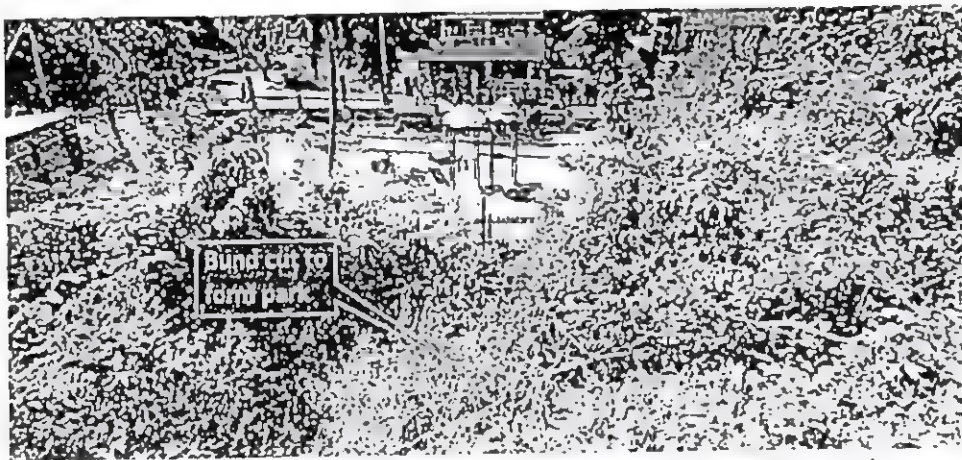
Photo 6(b) – Bund of Gowdanapalya tank cut to develop a park

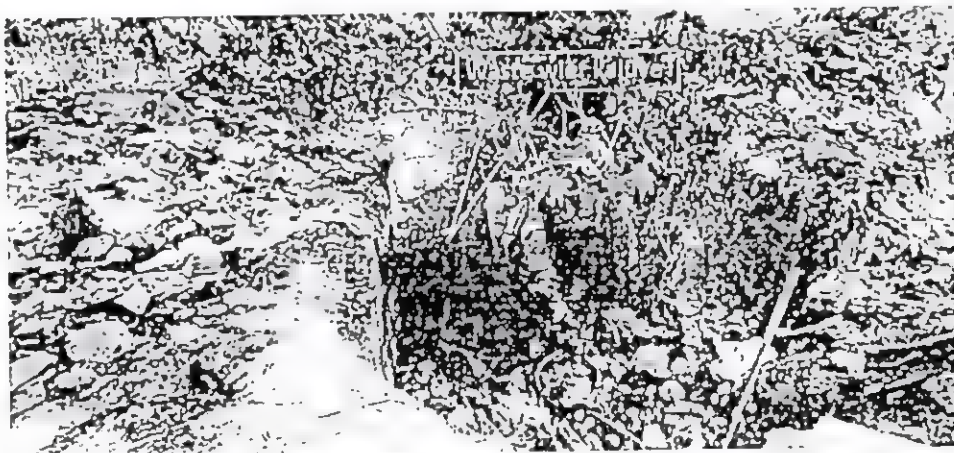
Photo 6(c)- Waste weir of Gowdanapalya tank almost closed with debris thrown-in

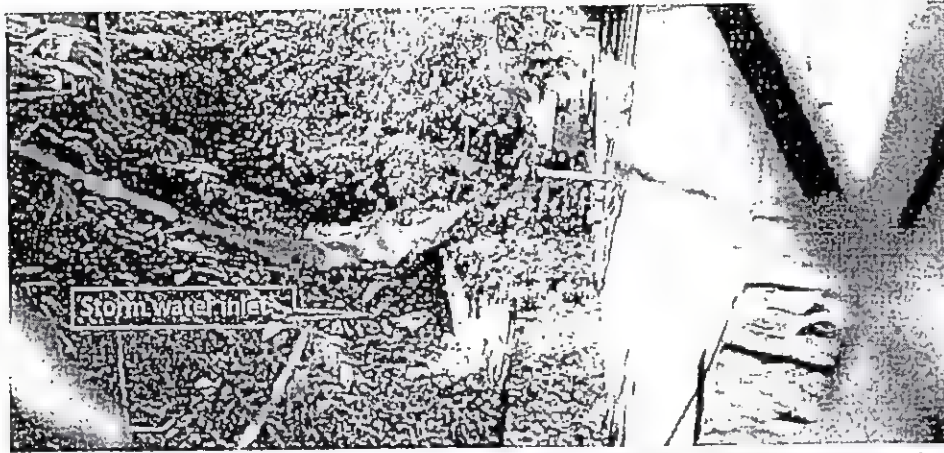
Photo 6(d) - Inlet of Gowdanapalya tank is completely choked with debris and Storm Water diversion work is taken up

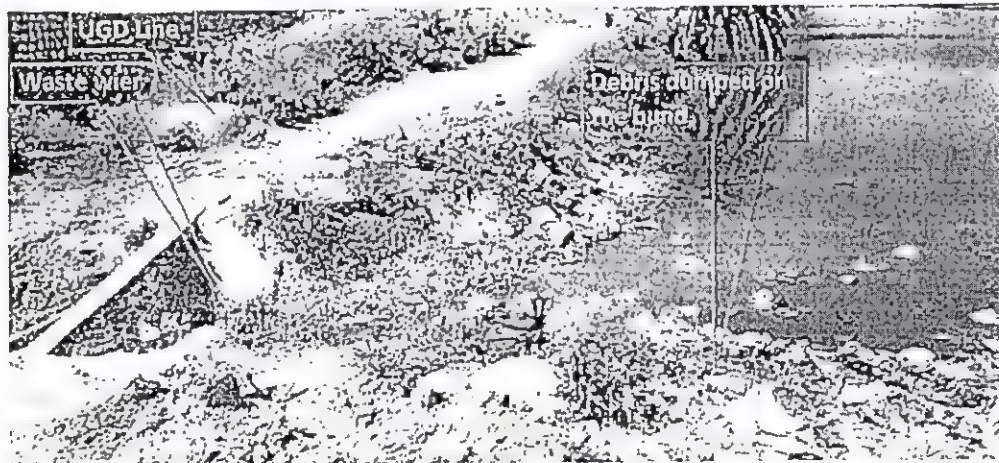
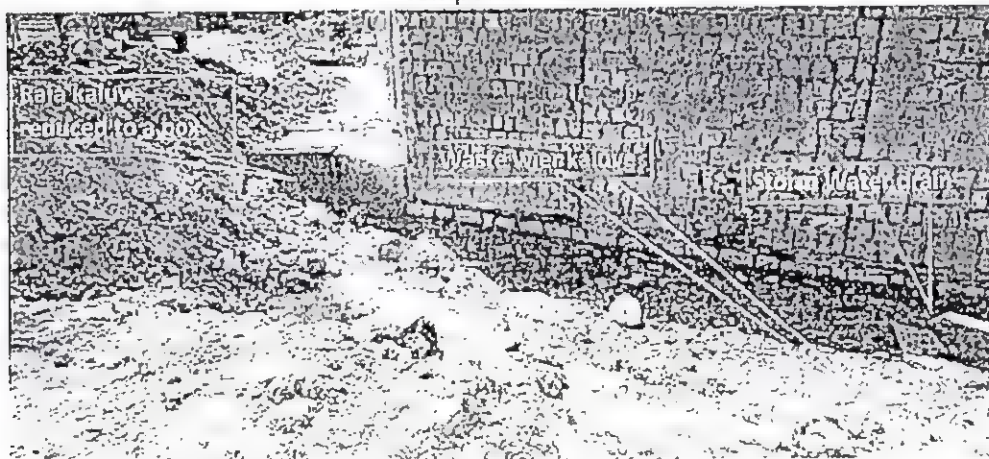
Photo 7(a) above & 7(b) below – Waste weir of Kelaginakere Bairasandra tank is completely encroached with debris. UGD lines are carried in the tank bund. Tank bund is encroached by filling the debris. Storm water drain is being constructed by the side of compound wall.

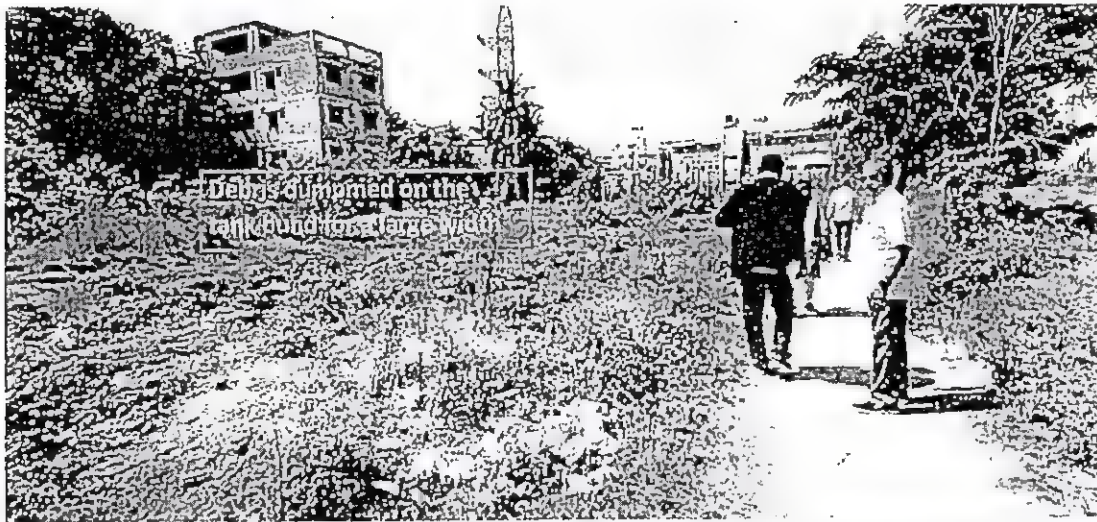
Photo 7(c) – Encroachment of Kelaginakere Bairasandra tank by dumping debris

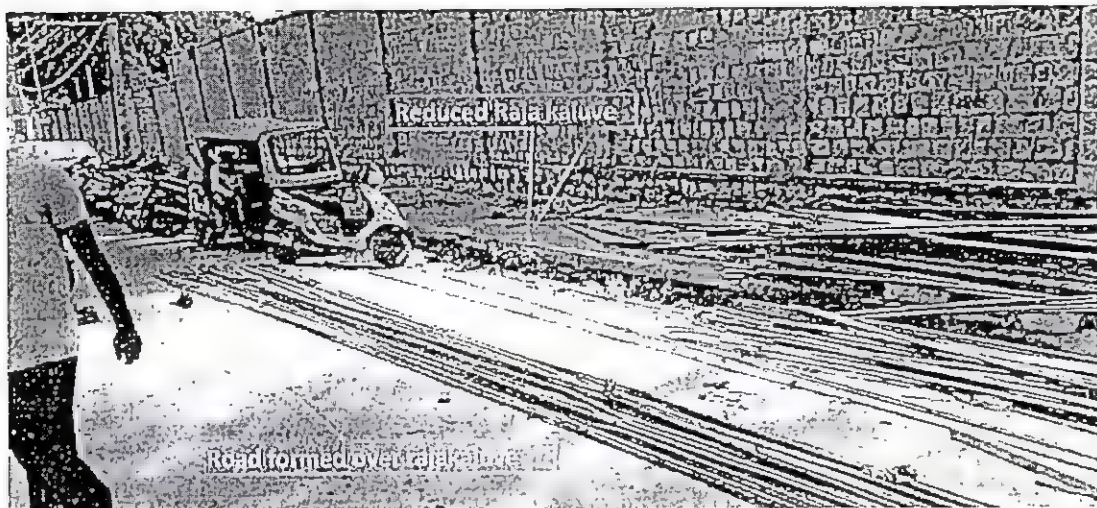
Photo 7(d) – Raja kaluve of Kelaginakere Bairasandra tank is reduced to a box drain of small section and a road is formed encroaching it.

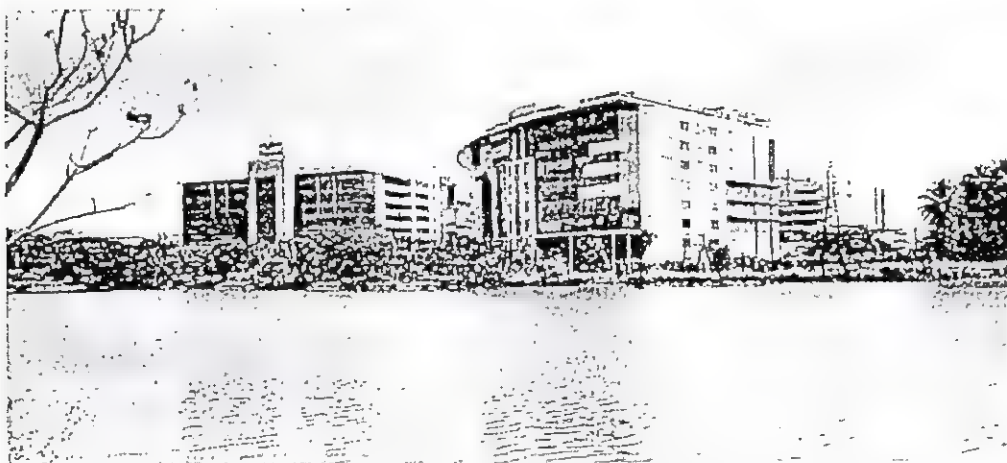
Photo 7(e) – Encroachment of Kelaginakere Bairasandra tank bund

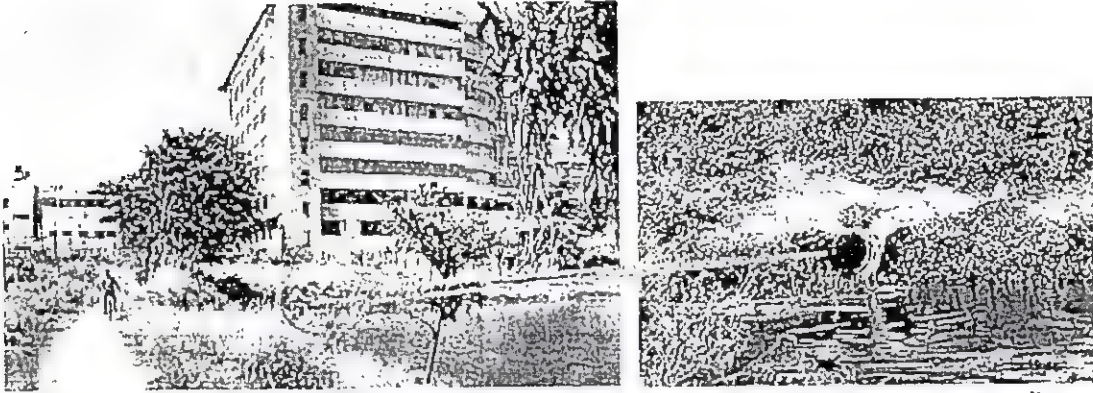
Photo 7(f) – Sewage water let into Kelaginakere Bairasandra tank from surrounding buildings

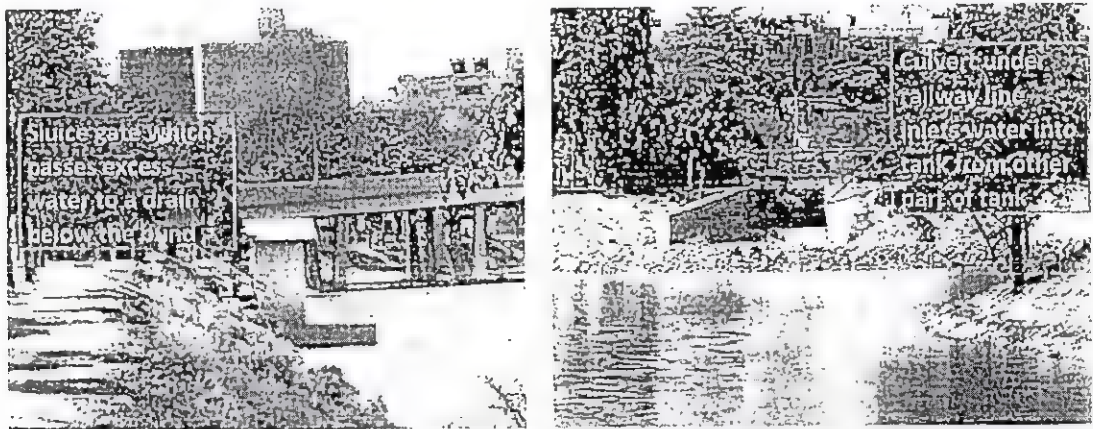
Photo 8(a) & 8(b) – Sluice and Inlet of Benniganahalli tank near K.R.Puram. There is no waste weir. It is divided into tanks by passing of a railway line. The other part of the tank is non accessible as it is surrounded by 3 railway lines in triangular pattern. Surplus water from that part of tank can pass off through the culvert under railway line.

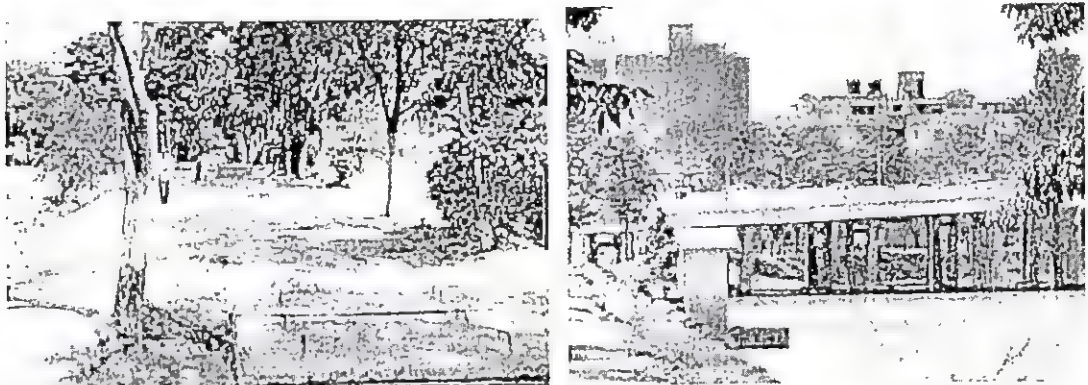
Photo 8(c) & 8(d) – Storm water line and chambers seen in the bund. Right side Flyover constructed in inside the tank. It was informed that it is proposed by BMRCL to reduce the bund width by constructing diaphragm wall in the bund and cutting off the outer part of bund to expand the road way below the tank in order to carry the Metro line in between the roadway.

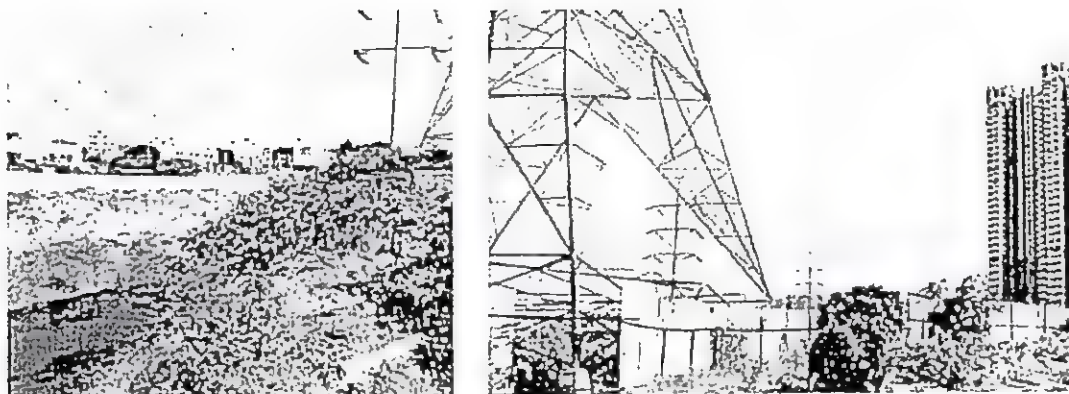
Photo 9 - Rajakaluve of Bhattarahalli tank is encroached and compound wall is constructed surrounding it by a builder

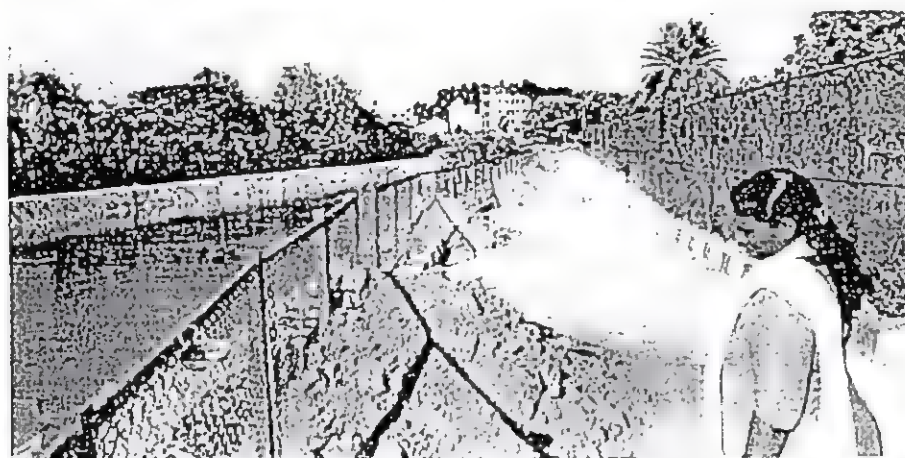
Photo 10 – Work being carried out in Kalkere tank bund independently by Horticulture without coordination with Lakes Division of BBMP

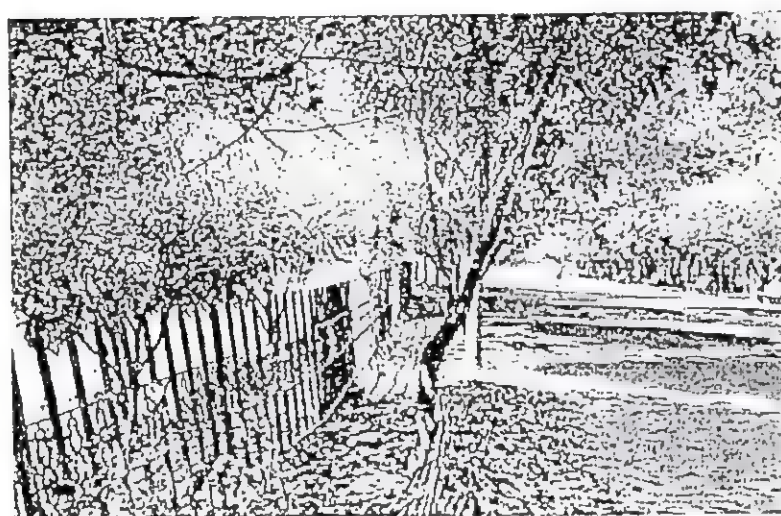
Photo 11- Tree planting and park development on the bund of Dorekere independently under Corporators' Fund and by a NGO without coordination with Lakes Division

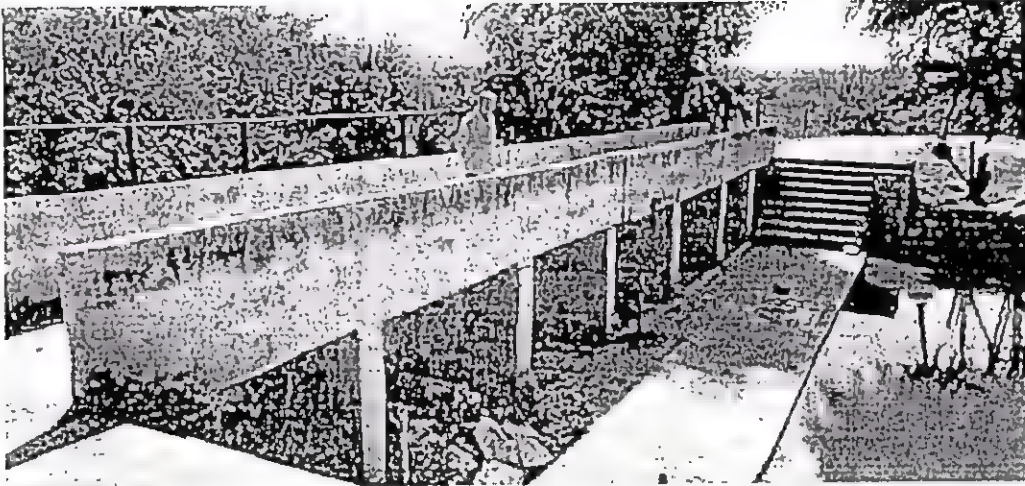
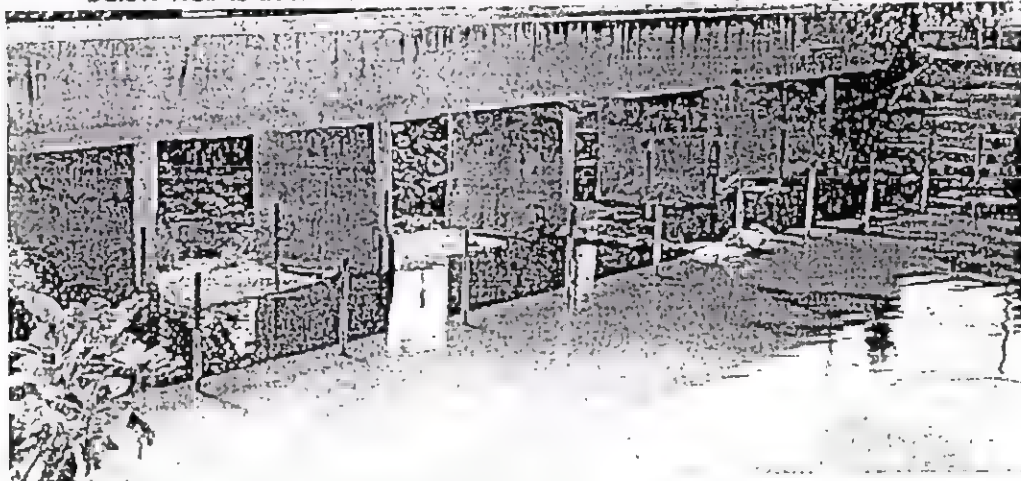
Photo 12(a) above and 12(b) below: Waste weir of Rachenahalli tank at two different levels. The above weir is at higher level and waste is being dumped surrounding it. The below weir is at lower level and water is continuously flowing over it.

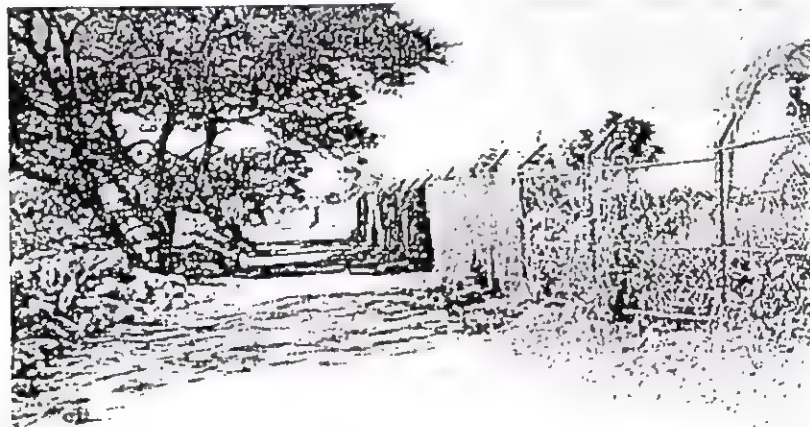
Photo 13- Doddabommasandra tank bund getting extended by the dumping of debris and in due course it has become a new road by the side of the tank.
